Journée d'étude - Studiedag

NAMUR - NAMEN 6 June 2011

#### IMPACT OF GEOLOGICAL AND ENVIRONMENTAL CONDITIONS ON THE PERFORMANCE OF MICROTUNNELLING

Wim Feyen, K-BORINGEN nv

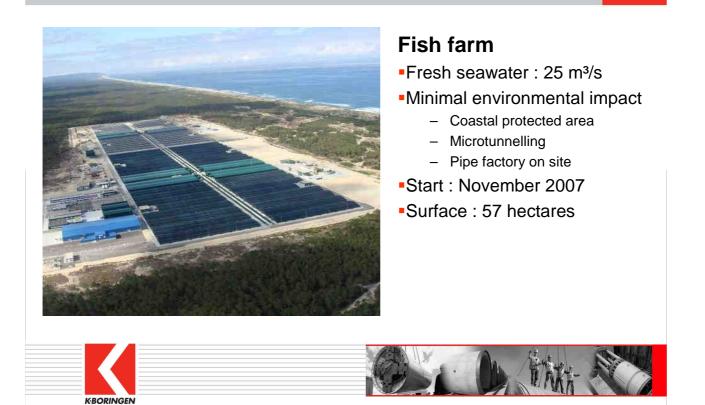
## Fish farm project in Portugal **General description**

#### Fish farm project in Portugal **General description Extension intakes** HDPE-pipeline ID: 2 x Ø 2,0 m $L = 4 \times 1.300 \text{ m}$ 2 intake tunnels (T1, T2) concrete pipes ID: Ø = 3,0 mL = 1.500 m each 2 outfall tunnels ( concrete pipes ID : Ø = 3,0 m and 2,6 m L = 1.350 m each **4 launch shafts** ID : $\emptyset = 20$ m, depth = 10 to 15 m diaphragm walls, 32 m deep Reaction wall : 3000 tons / Soft eyes GFRP KBORINGEN

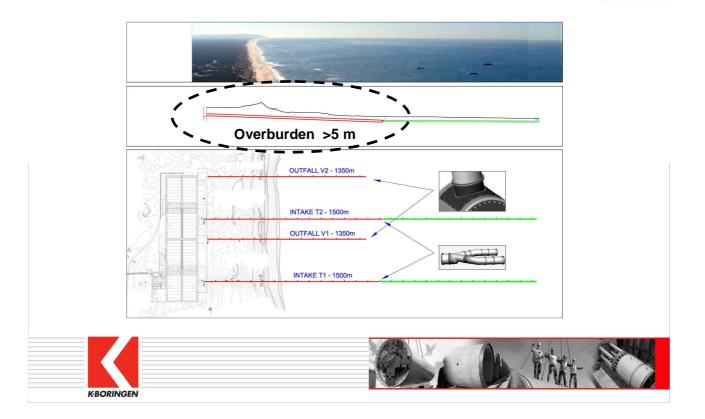
## Fish farm project in Portugal Longitudinal profile

#### Fish farm project in Portugal **Challenges / critical points** ATLÂNTICO Length of the jackings The tight time schedule 8. .. 300 Start : december 2007 V1 **T1** Phase 1a November 2008 **T2** February 2009 Phase 1b V2 February 2010 Phase 2 Geology (lack of data) Longitudinal profile (depth, curve, overburden beach) Influence of the sea KBORINGEN

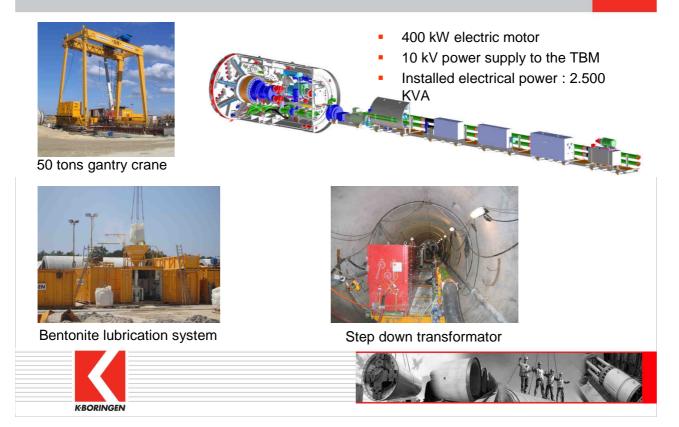
## Fish farm project in Portugal **Microtunnelling equipment**

TBM with OD 3800 mm AVND 2400 HK with extension kit

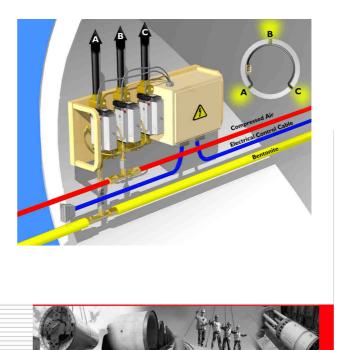
Automatic bentonite lubrication system

- Mixture of bentonite + additives for lubrification + face support
- Mixture adapted to :
  - Geological conditions
  - Water quality
  - Presence of salt water

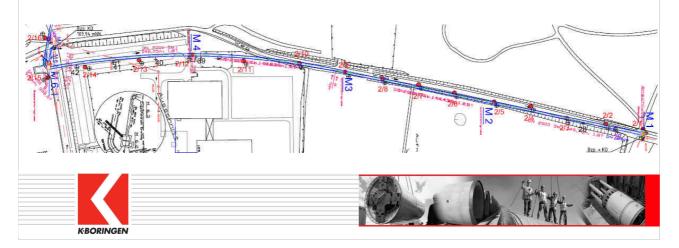
- Very detailed description of geology and hydrogeology based on :
  - Geological map

- Soil investigation
  - Borehole probing every 25 to 30 m
  - particle size curve, SPT, f, ...
  - Groundwater observations and chemical analysis
  - Abrasivity (CAI), Sticking potential

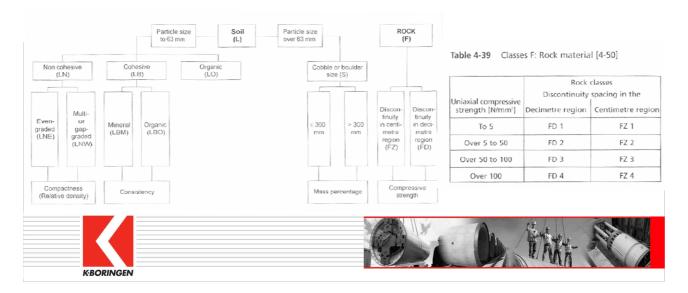
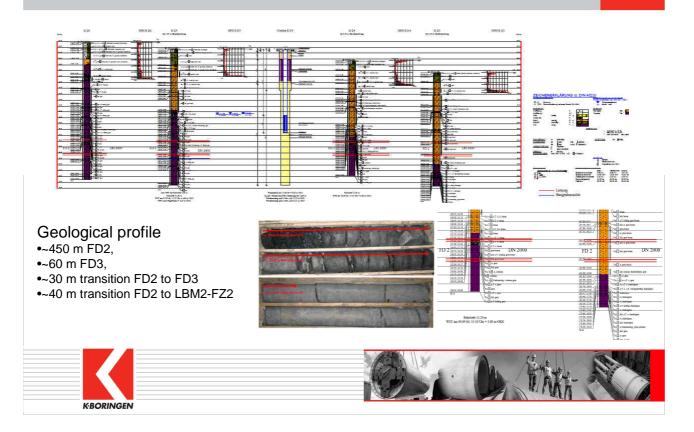
- Bodengutachten Dr. Höfer : Soil described according to DIN18300 + 18319
  - DIN18300 soil is defined in 7 soil and rock classes
  - DIN18319 defines soil and rock classes for trenchless technology
    - Soil and rock types summarized into 5 main classes
    - In addition division for 12 soil classes and 8 rock classes and 4 classes for stones

- Microtunnelling principally in Limestone "Tonstein" and Sandstone
  - Tonstein is a distinctive type of rock, composed largely of the mineral kaolin (clay mineral).
  - Tonstein is very low abrasive (CAI 0,5-1,0)
  - heavily weathered until not weathered compacted rock
  - Low sticking potential
  - According to soil investigation possibility :
    - Geological fault (Hacheneyer Sprung)
    - Influence of mining activity + coal layers

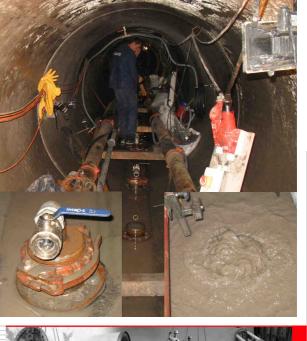
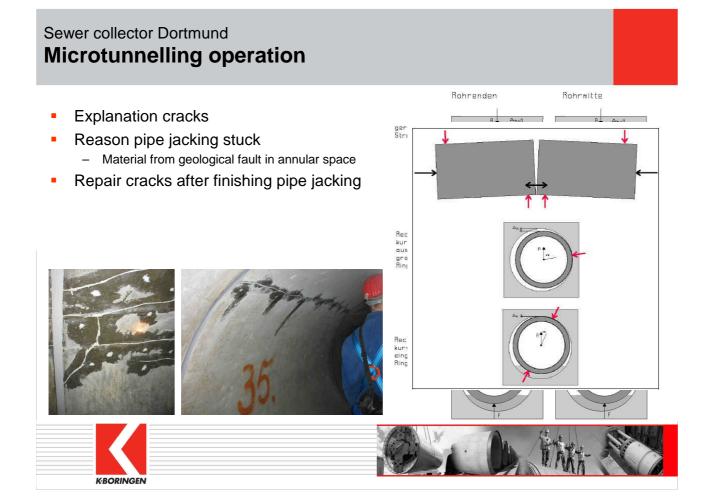
#### Sewer collector Dortmund **Microtunnelling operation**

- •Core drilling DN150 (pipe 31 35)
- Removing material annular space
  - By hand + wash out under high pressure
- Pipe jacking free
  - 12 days of standstill
  - 10 to 15 days reduced production
  - Cracks closed / no new cracks

- Longitudinal + radial Cracks
  - width cracks 0,1–1,4 mm
- Opening bentonite injection holes
  - Bentonite under pressure
  - Top against rockformation
  - Underneath 6 cm overcut
  - Material in overcut
